Slow Motion Spills: Coal Combustion Waste and Water in Kentucky

A Report by the Sierra Club, Kentucky Waterways Alliance,
and Global Environmental, LLC

Researched and written by Mark Quarles, P.G., and Craig Segall

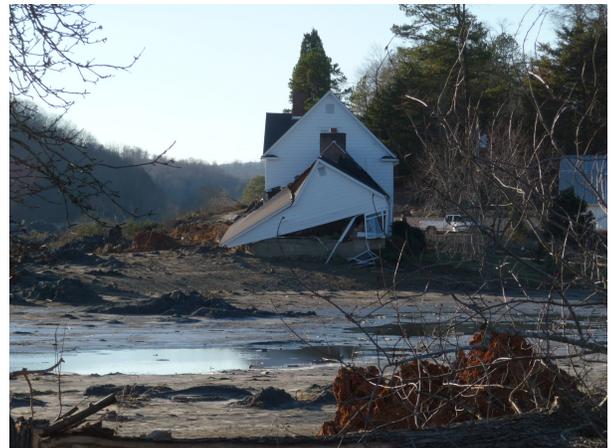
After the Kingston spill.
Photo courtesy Lyndsay Moselely.

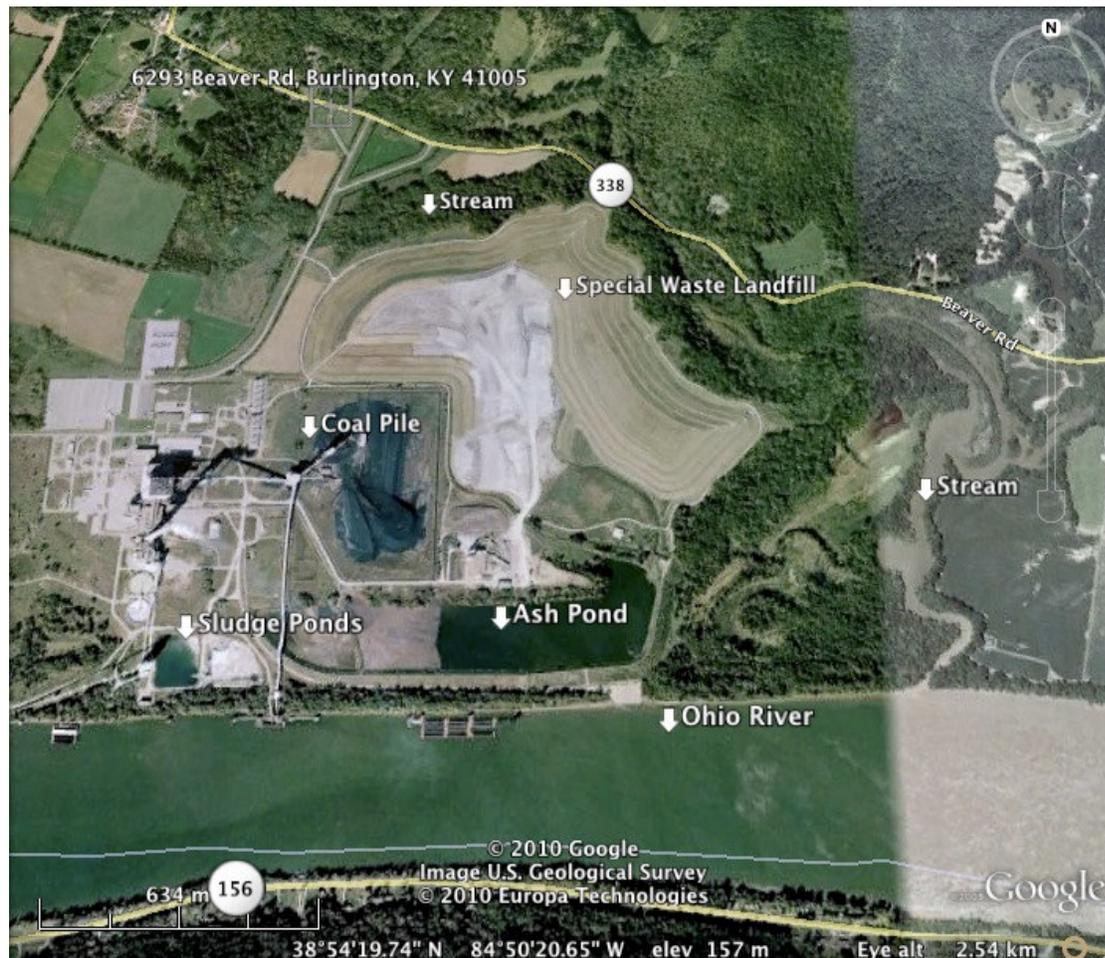
Aerial Photo – East Bend

The results of temperature measurements obtained during groundwater sampling in July 1998 indicate that the well nearest the ash pond (MW-4) had a groundwater temperature 15° F hotter (73.5° F) than the typical shallow aquifer well on-site (59° F) – suggesting that the ash pond is leaking to the shallow aquifer.

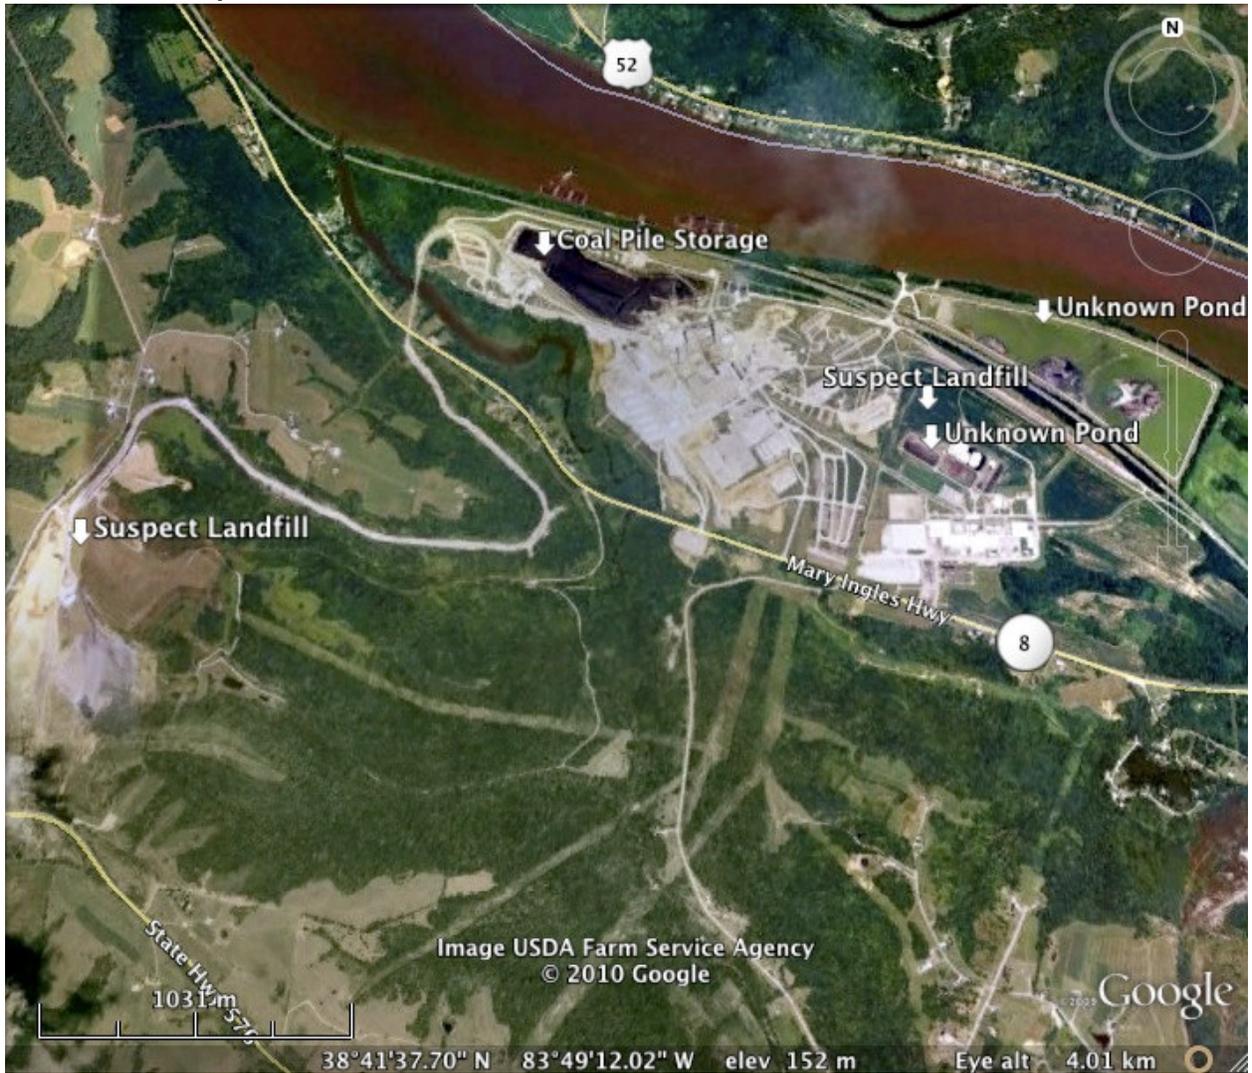
Aerial Photo – Spurlock

Aerial photography suggests that un-permitted wastewater treatment ponds, a 0.7-mile long ash pond, and a landfill exist. Groundwater monitoring data indicate that one lined, permitted coal combustion waste landfill has been leaking since at least 2005, as indicated by coal combustion waste parameter concentrations that exceed EPA drinking water standards – particularly arsenic (16 times higher than the standard), sulfate (3.5 times the standard), iron (3 times the standard), and total dissolved solids (4 times the standard). Both the concentrations of contaminants and the number of contaminated wells worsened over time. Although statistical analyses are required to be performed on groundwater samples, EKPC only completed one analysis (in 2006) and later claimed that not enough data were available to perform a meaningful analysis – even though the 2006 analysis indicated multiple statistically significant increases (SSIs) in parameter concentrations. The Division does not require that a potentiometric surface diagram be submitted with groundwater reports and as a result, the Division is unable to determine the location of any well or the direction and rate of groundwater flow at the site. The site is located adjacent to the Ohio River.

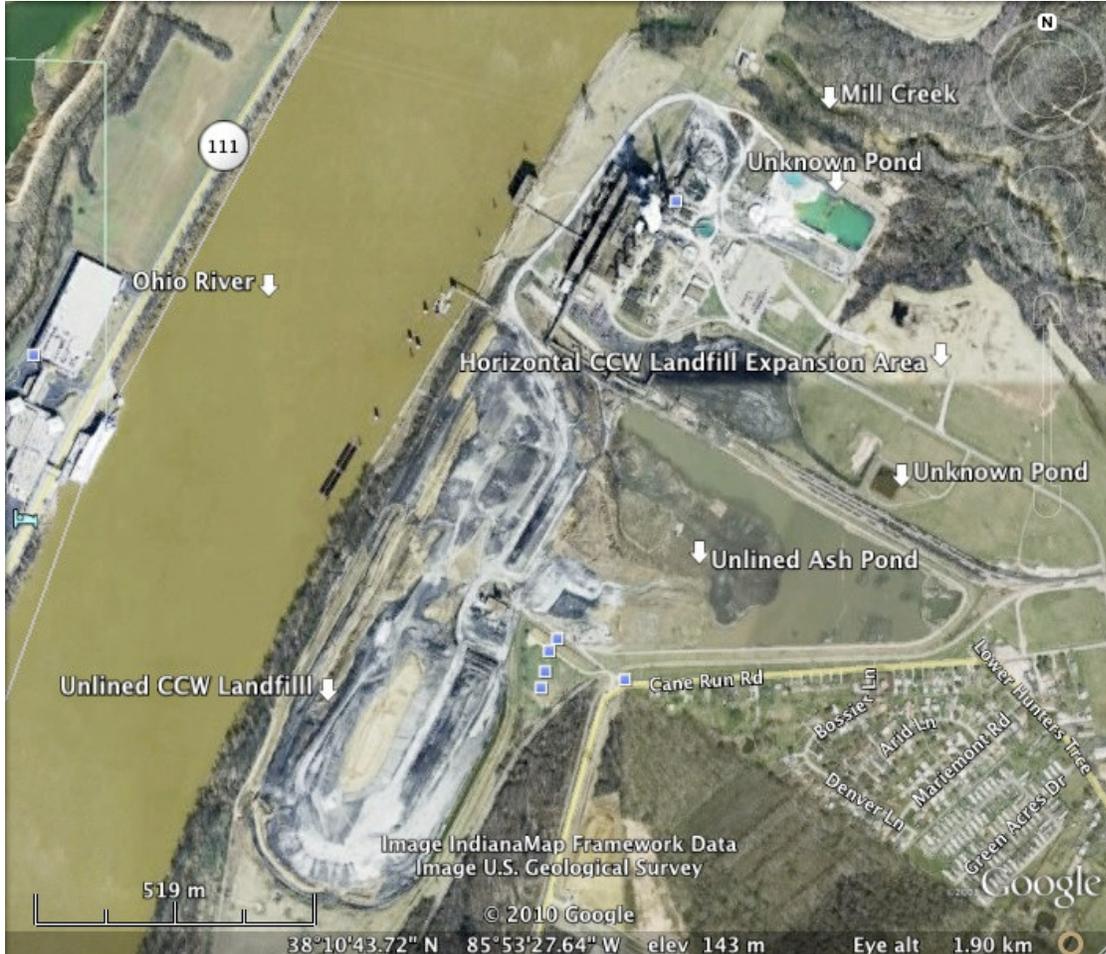
Aerial Photo – Cane Run

The power plant location adjacent to the Ohio River suggests that shallow water table aquifer conditions exist. No potentiometric surface diagrams to determine the direction and rate of groundwater flow were found in the file because the Division does not require that they be prepared. The results of temperature measurements obtained during groundwater sampling in November 2008 suggest that the ash pond and landfill are leaking to a shallow aquifer.

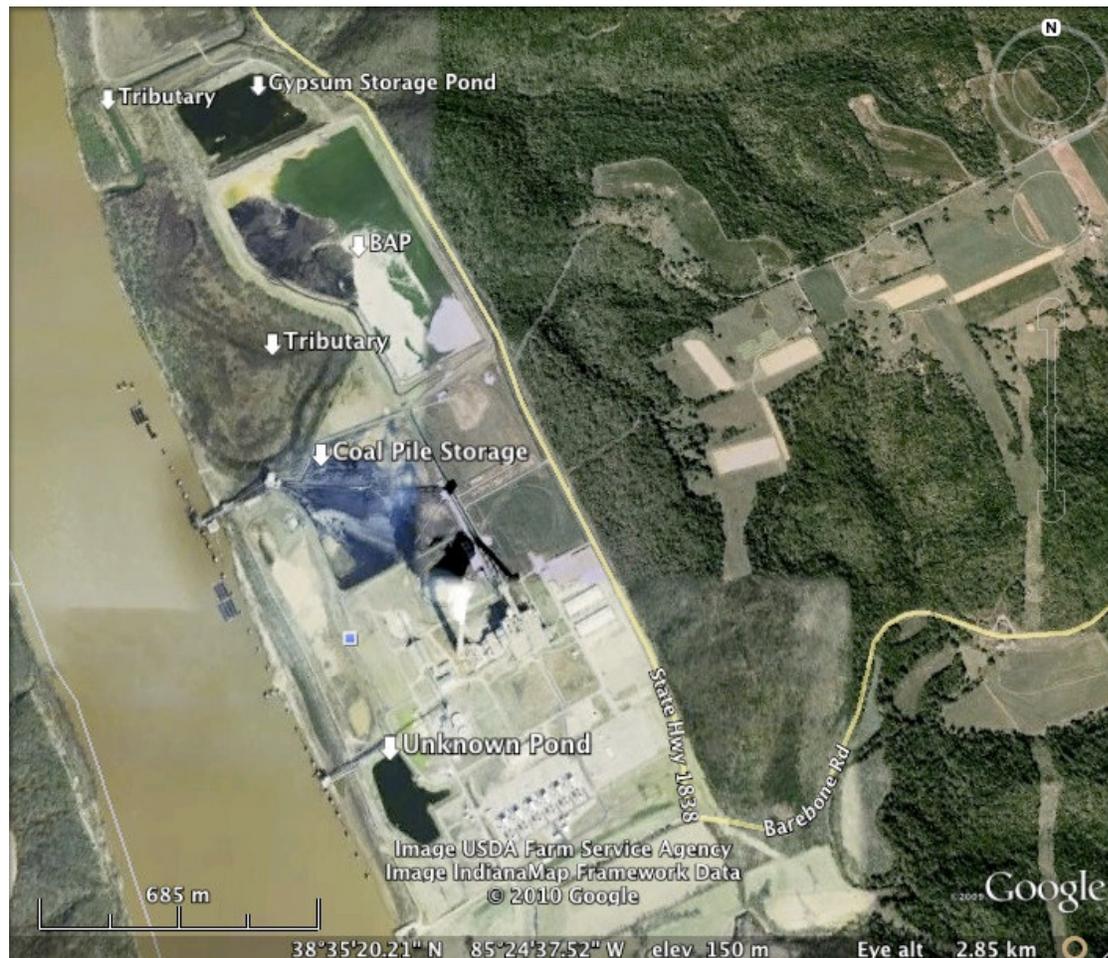
Aerial Photo - Trimble

One unlined pond that is nearly ¾-mile long has been used to dispose of coal combustion wastes since the 1980s. LG&E proposed a 30-foot tall vertical expansion of that pond in 2009 – even though groundwater data since at least 2003 indicates that the pond is leaking, and drinking water standards have been exceeded in nine (9) of 12 wells on-site. Groundwater parameter concentrations are up to 10 times higher than allowable EPA standards for chlorides, total dissolved solids, and sulfates. The current monitoring program is less stringent in terms of required analyses than what was required in 1996 because no heavy metals testing has been required since at least 2003 – even though coal combustion waste constituents have been reported in the groundwater, and heavy metals are common in coal combustion wastes. The Division does not require a potentiometric surface diagram be submitted with groundwater reports and as a result, the Division is unable to determine the direction and rate of groundwater flow. The site is located adjacent to the Ohio River, and contaminated wells are located within 250 feet of a tributary stream to the Ohio River.

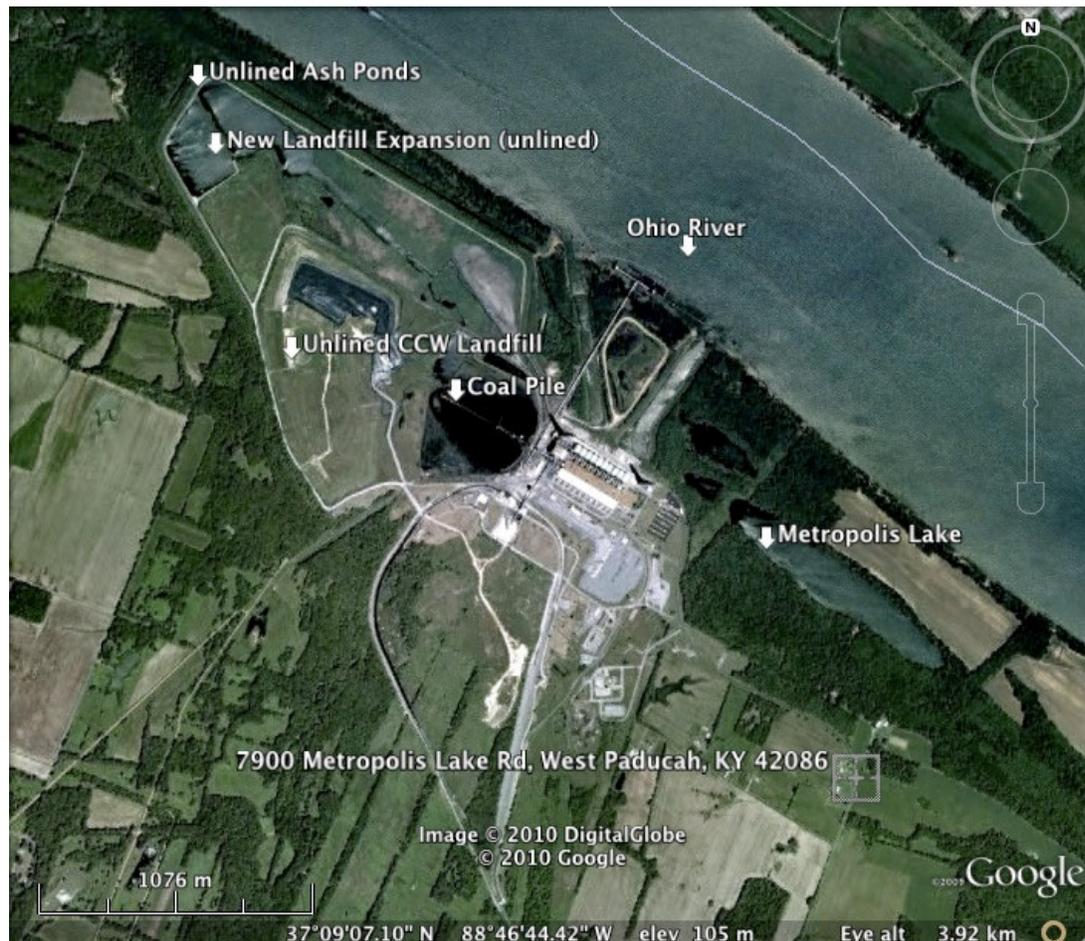
Aerial Photo - Shawnee

Two unlined ash ponds and two unlined landfills exist at the site for disposal of coal combustion wastes. The ponds and landfills are located adjacent to the Ohio River. The most recently permitted landfill was approved without a liner in July 2007, although groundwater contamination from an older unlined landfill and ash pond indicates that those disposal units are leaking. The new landfill is being built over old unlined ash ponds. Groundwater contamination above one or more standard exists in all eleven (11) downgradient wells. The most notable groundwater contaminants above regulatory standards include: boron (up to 7.5 times higher than the EPA health advisory); arsenic (slightly higher than the EPA MCL); and selenium (almost 2 times the standard). No potentiometric surface map was found in the file review to determine placement of wells, direction of groundwater flow, or gradient of the water table aquifer because the Division does not require this information to be submitted.

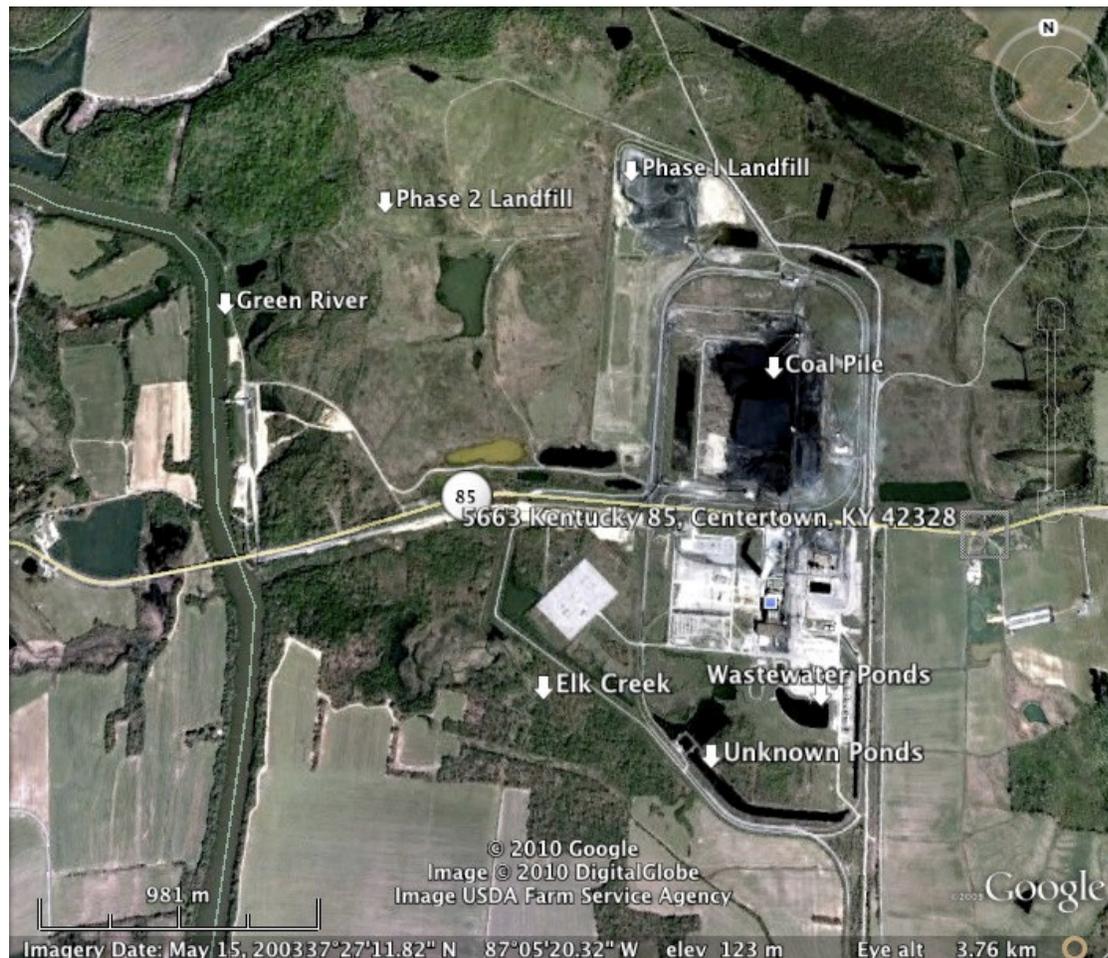
Aerial Photo - D. B. Wilson

Current aerial photography (attached) indicated that at least one suspect ash pond also exists at the site. Historic maps found in the file also illustrated wastewater treatment ponds south of the station, and those ponds are located approximately 250 feet north of Elk Creek, a tributary of the Green River.

According to the file review, the plant was constructed in 1984; the station and the waste disposal units were constructed over strip-mined areas; the ground surface is void of natural soils; the coal combustion waste is placed directly on top of the soil; and neither of the landfills has a liner.
